**Geological and Hydrological Survey
for the Tintareni Landfill. Summary**

Moldova: Chisinau Solid Waste Project
Feasibility Study

Summary Report

November 2016

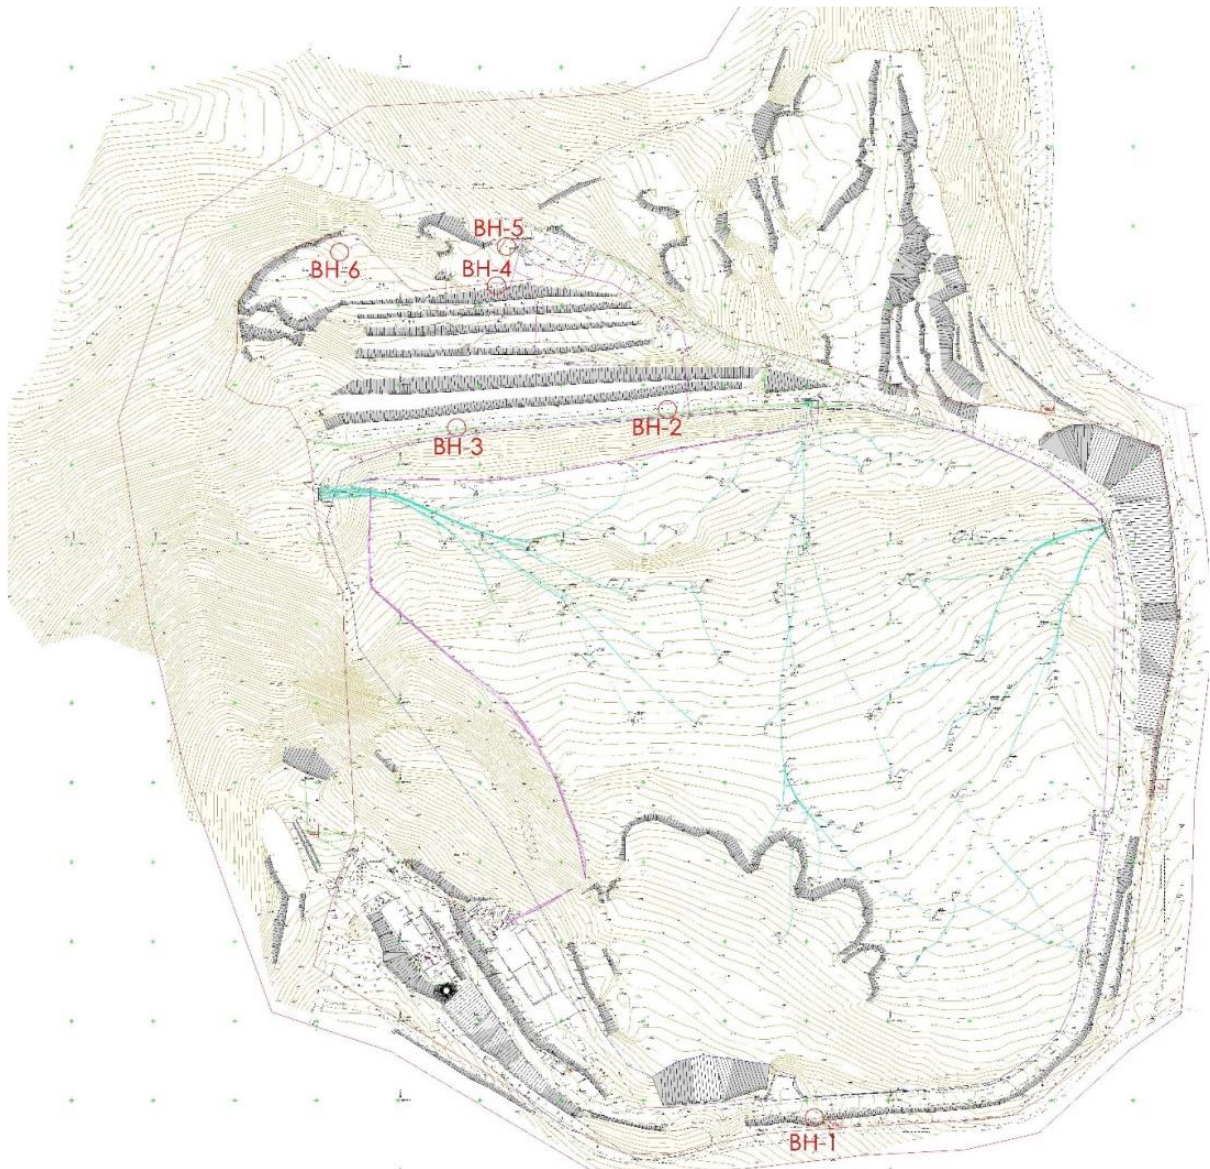
Figure 1: Location of boreholes (BH)

Geological prospecting works were carried on land in unincorporated area of the village Tintareni, Anenii Noi district, Chisinau Municipality landfill site. The works were carried out by a team of geologists and hydrogeologists in the period of May to July, 2016. Six drillings were executed on the polygon household waste land in the village Tintareni of Anenii Noi district, and has an average depth of: BH1=81 m, BH-2=33m. and BH3=33 m, BH-4=14m, BH-5=15m and BH-6=15 m.

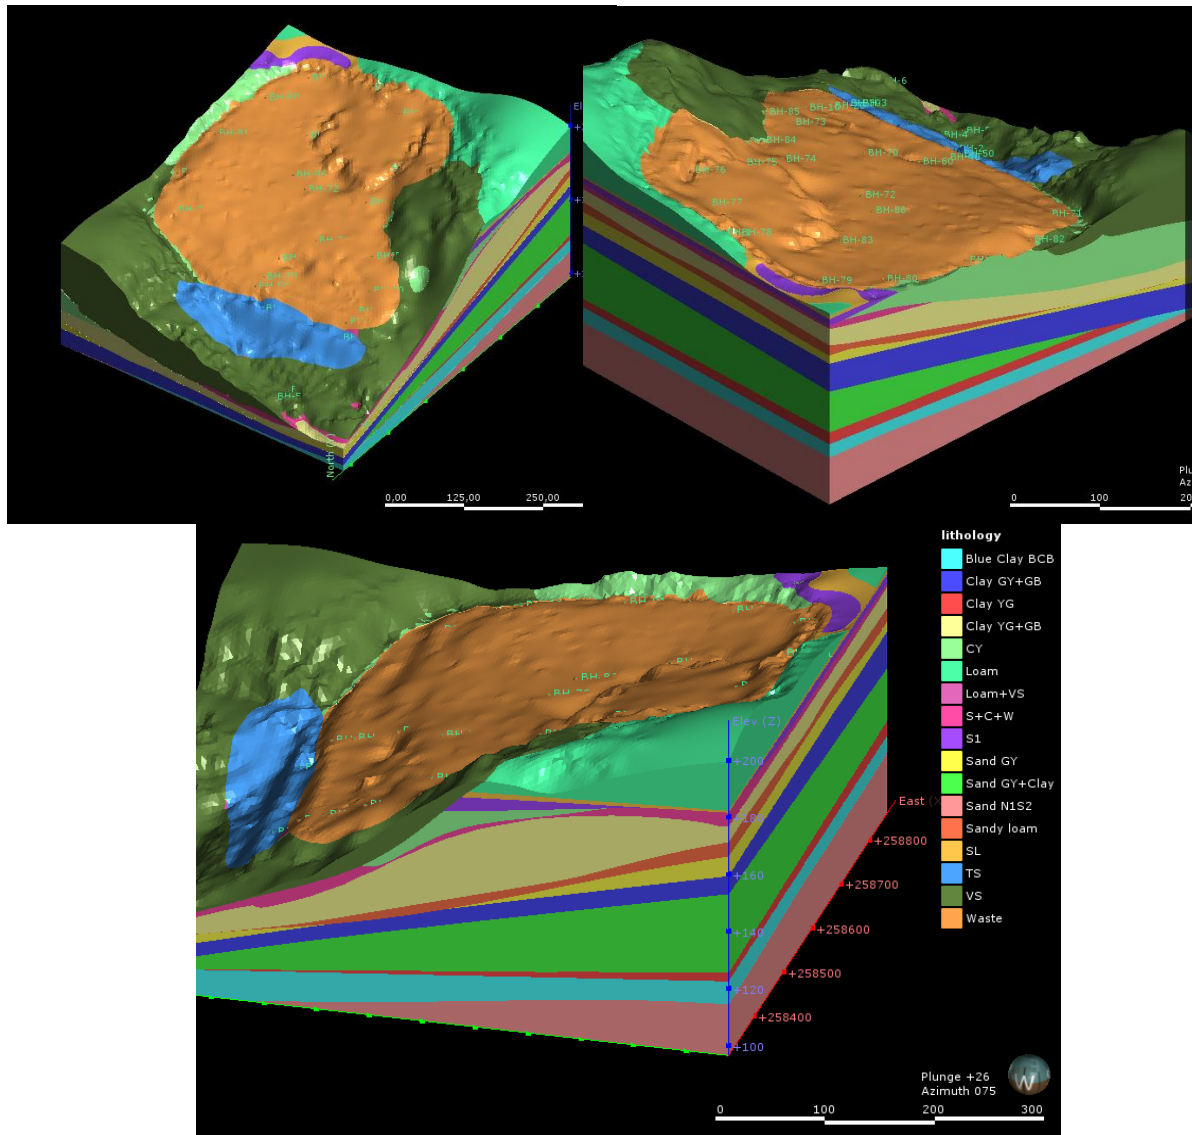
Figure 2: 3D representation of intersecting lithologies

Slope is subject to works on solid waste depositing and waste gas exploitation. The site has an inclination towards the NW direction. The slope is located on the sediments of an ancient slide, with observed surface irregularities and well-developed planar and linear erosions.

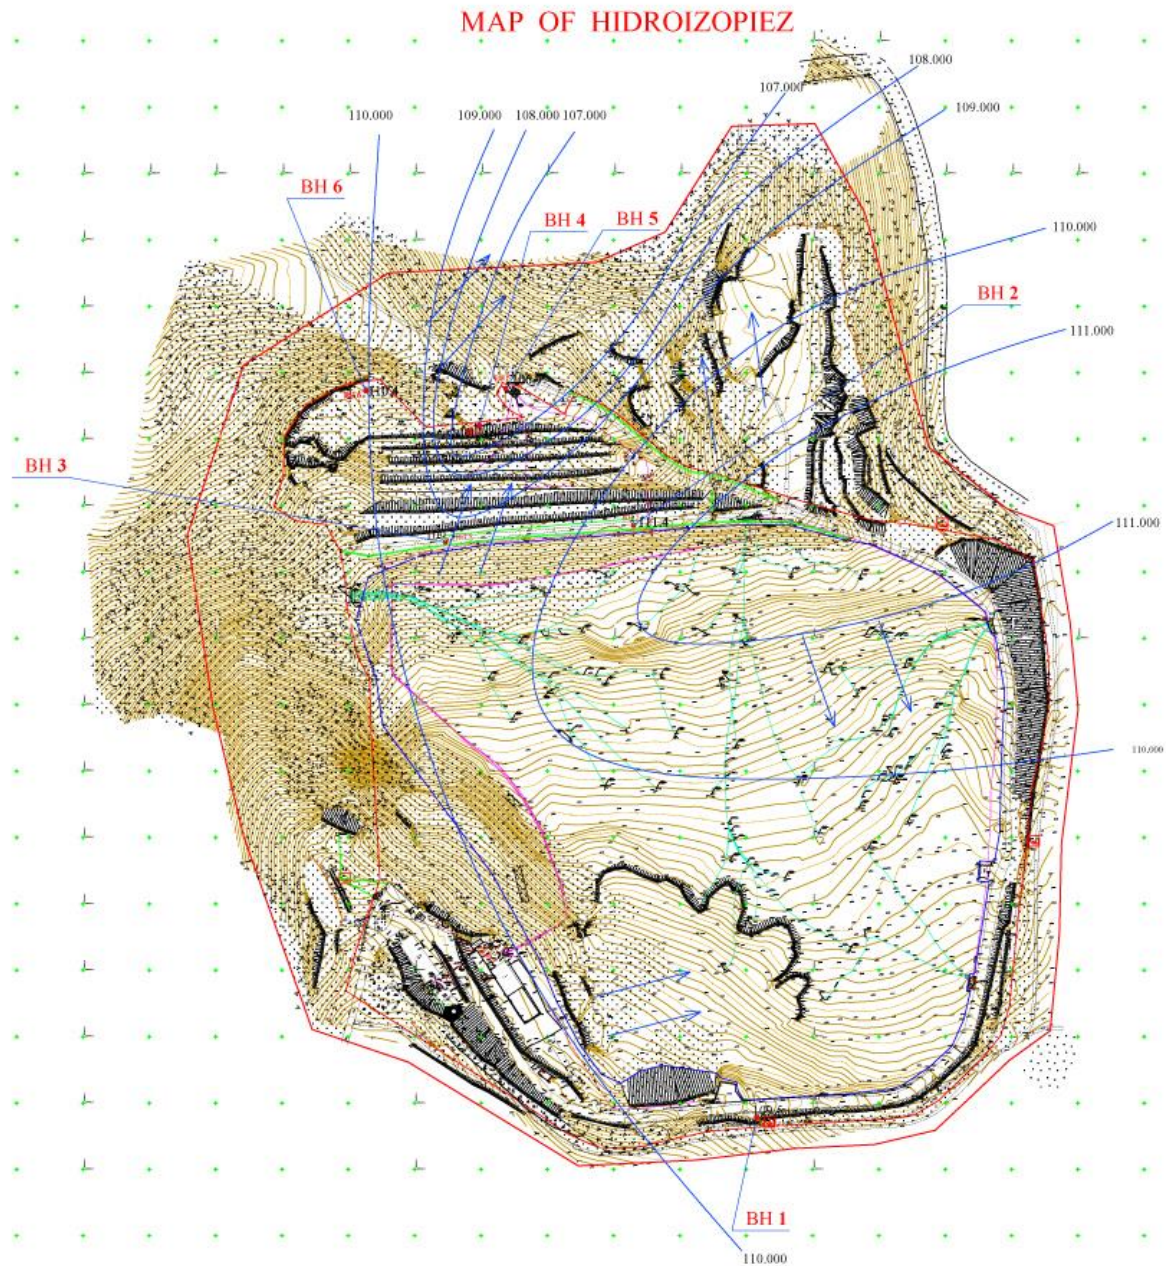
Figure 3: Map of hidroizopiez and groundwater flow direction

All six boreholes and additional locations (river Bic, leachate tank, well 400m to the dam, well for drinking water and artesian well) have been sampled for water. BH3 is located in the section remediated after the land slide in 2003 and thus in addition to the clay layers contains some sand bands (three thin layers, approx. 10-15cm). These unwanted sand bands contain liquid coming from the waste cell. The impact assessed at the location of BH3 is not high, however it clearly shows a leakage. The impact migrates towards north where it can be verified by the analysis of the water samples taken from other boreholes (BH4 and BH6). The analysis shows that the magnitude of the impact is significantly lower due to the more distant location of the boreholes to the point of leakage. The analysis of all other samples as listed above (except for the leachate tank), do not show any impact from the landfill.

The laboratory results for water from the wells located in Tintareni village showed that no impact from the landfill is present. Based on composition of the water from the well a conclusion could be made that the most possible cause of water contamination is agricultural activity. Rehabilitation measures required in order to avoid any leachate leakage from the waste cell shall be included into the project proposal.
